What we have now?

At an NPL site, additional sampling data was collected in 2010 to assist with the site contamination re-evaluation.

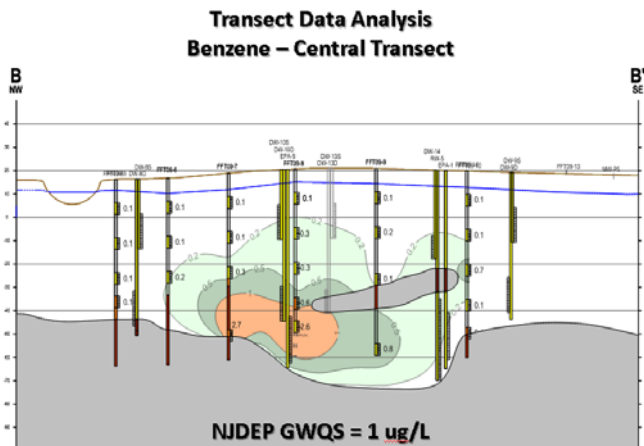
VOCs in groundwater downgradient of the source, direct-push groundwater sampling data from two “far-field” transects, the Northern and the Central Transects, as well as on the third transect, the Southern Transect near the receptors (surface water and groundwater supply wells) was collected and analyzed. It was concluded that the plume extent is limited off-site, by the Central Transect, and that the source control remedial system on-site is performing well, requiring limited modification. Groundwater to surface water interaction was analyzed and it was concluded that there are no impacts. Fate and transport modeling lead to similar conclusions.

A technical meeting will be held with USEPA and NJDEP to discuss reducing the number of monitoring wells off-site, one for each transect, placed along the centerline of the dilute downgradient plume only. In addition, a plan for delisting the Site Lot portion of the site will be presented. These near-term monitoring program- and site use changes will be followed by source remediation to eventually allow overall site closure.
